Sunland Division 7 Condo *Sequim, WA*

Report #: 23127-10
Beginning: January 1, 2026
Expires: December 31, 2026

RESERVE STUDY Update "With-Site-Visit"

March 28, 2025

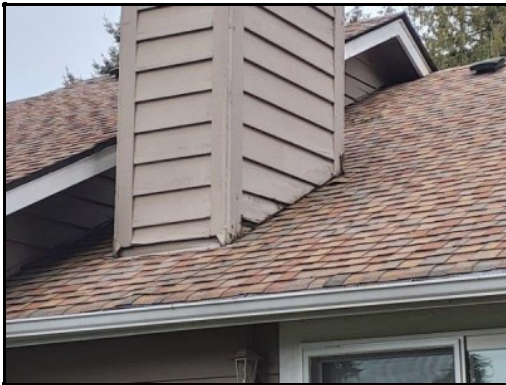
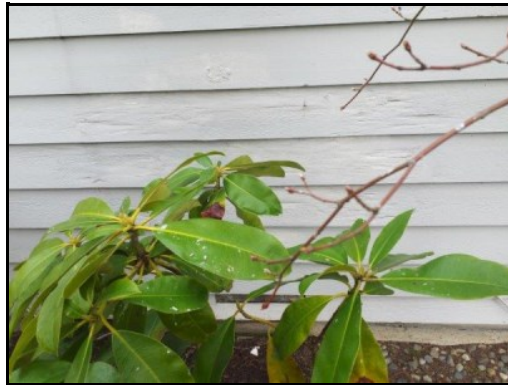
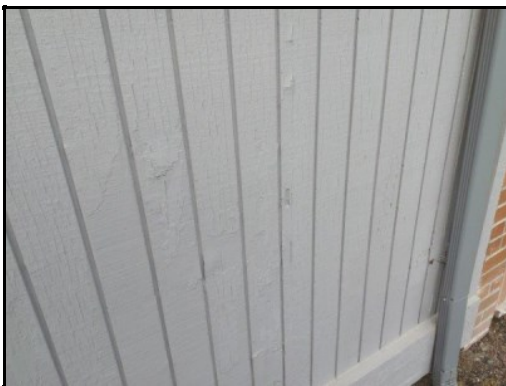
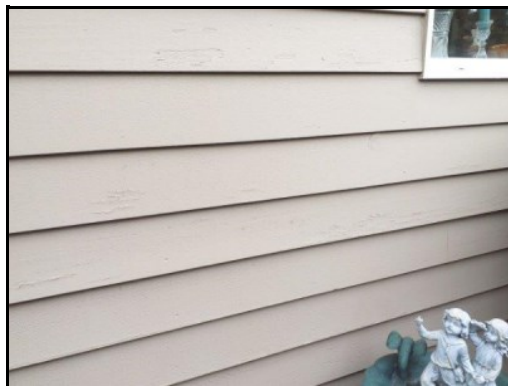
The below images illustrate observations of chipping and failed paint, some exteriors showed signs of wood decay.

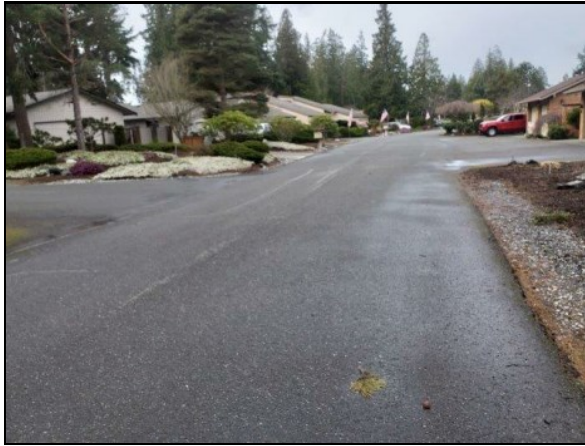
Comp #: 110 Asphalt - Partial Replace**Quantity: ~ 45,600 SF****Location:** Asphalt driveways, parking within community**Funded?:** Yes.**History:** 1998, resurfaced**Comments:** Some cracking and general raveling were noted.

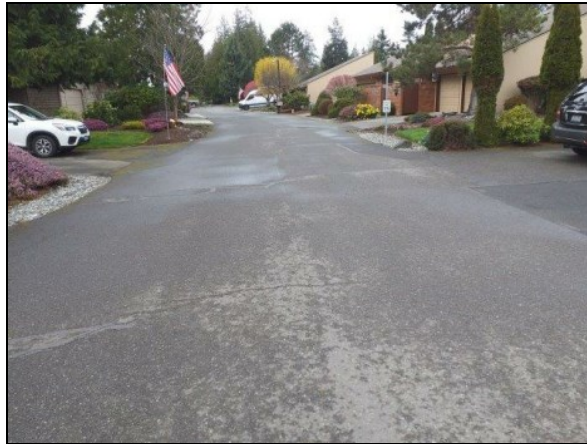
Comp #: 112 Asphalt - Repair/Sealcoat**Quantity: ~ 45,600 SF****Location:** Asphalt driveways, parking within community**Funded?:** Yes.**History:** 2024 ~\$17,321; 2023 ~\$3,300, crack fill; 2022 ~\$5,900 repairs**Comments:** Some cracking and general raveling were noted.

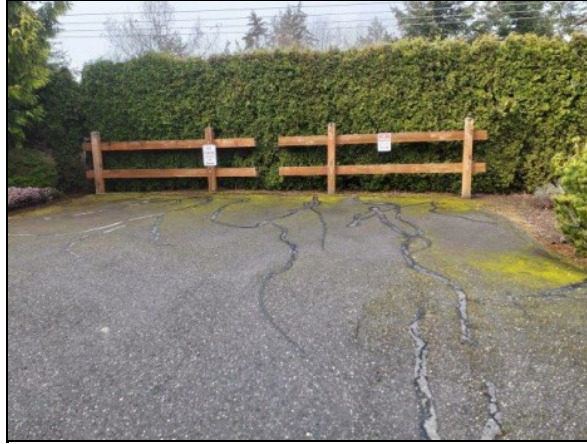
Comp #: 132 Guard Rail - Replace**Quantity: ~ (30) LF / Wood****Location:** Adjacent to West perimeter, terminus asphalt drive**Funded?:** No. Cost projected to be too small for reserve funding**History:** None known**Comments:** No obvious damage was noted.

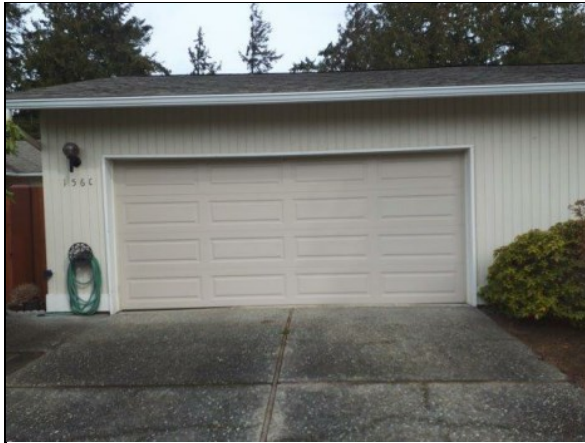
Comp #: 595 Garage Doors - Replace**Quantity: (63) assorted****Location:** The garage entrance.**Funded?:** No. Large-scale repairs or replacements are not predictable.**History:** 2023 ~\$2,757 (1) replaced; 1999 (1) Replaced**Comments:** The metal frame garage doors are assumed to be operational. No damage was observed.

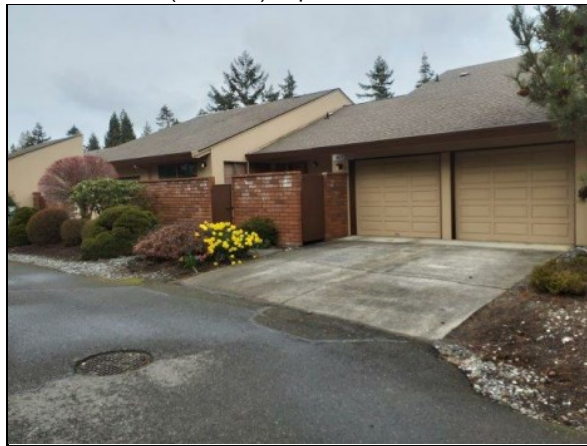
Comp #: 600 Comp Roof (126) - Replace**Quantity: ~ 10,100 SF****Location:** Rooftop of Units #126**Funded?:** Yes.**History:** 1997**Comments:** This component factors the roof for Building #126, which was reportedly last replaced in 1997.

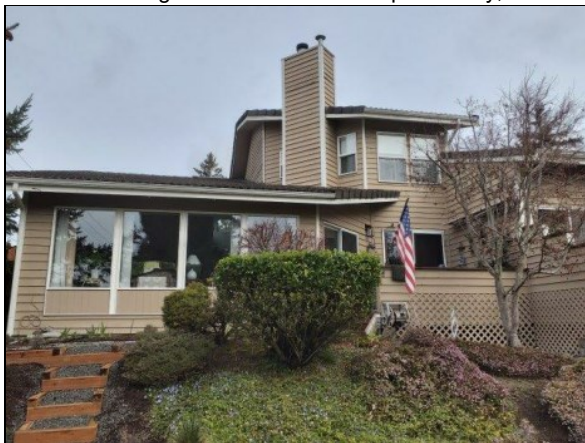
Comp #: 618 Gutters/Downspouts - Replace**Quantity: ~ 6,300 LF****Location:** Perimeter of buildings**Funded?:** No. Funding included within similar components; no separate funding necessary**History:** None known**Comments:** Based on our limited visual inspection, the metal gutters and downspouts appeared to be functional.
