Sunland Division 7 Condo *Sequim, WA*

Report #: 23127-10
Beginning: January 1, 2026
Expires: December 31, 2026

RESERVE STUDY Update "With-Site-Visit"

March 28, 2025

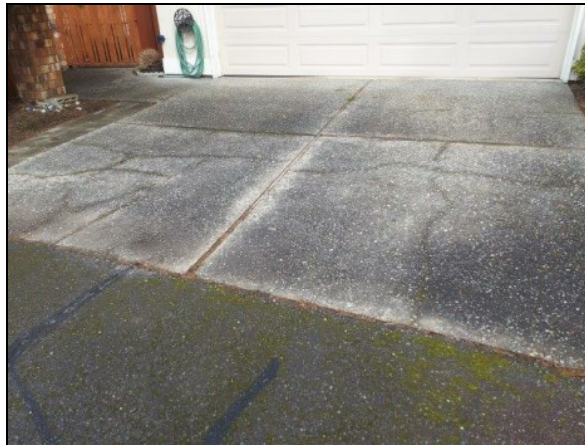
Comp #: 110 Asphalt - Partial Replace**Quantity: ~ 45,600 SF****Location:** Asphalt driveways, parking within community**Funded?:** Yes.**History:** 1998, resurfaced**Comments:** Some cracking and general raveling were noted.

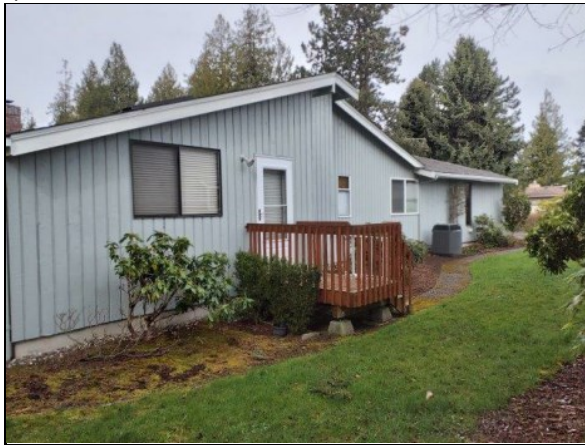
Comp #: 535 Windows & Sliders - Replace**Quantity: Extensive / Assorted****Location:** The exterior building walls.**Funded?:** No. Historically handled through the operating budget**History:** 2024 ~\$5,308; 2019 ~\$5,000; 2016-2018 ~\$9,400

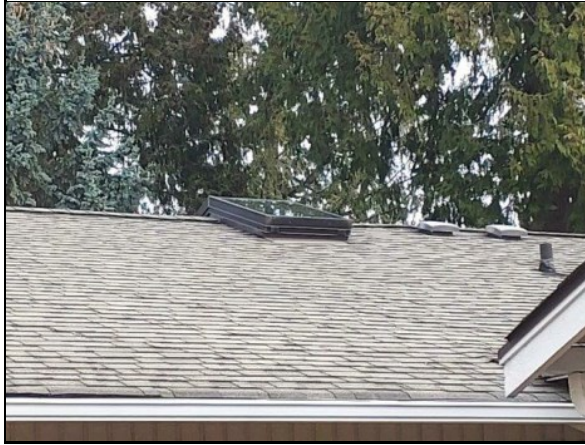
Comp #: 602 Comp Roof (125/133) - Replace**Quantity: ~ 17,000 SF****Location:** Rooftop of Units #125 & #133**Funded?:** Yes.**History:** 2002**Comments:** This component factors the roof for Buildings #125 & 133, which were reportedly last replaced in 2002. See Component #600 for more detailed comments and recommendations.**Useful Life:**

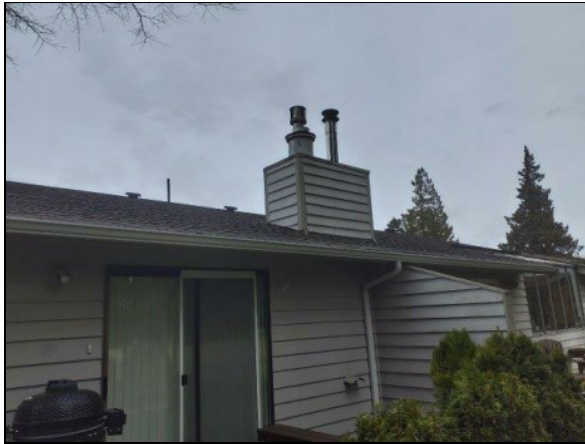
Comp #: 602 Comp Roof (137/138/140) - Replace**Quantity: ~ 15,200 SF****Location:** Rooftop of Units #137, #138 & #140**Funded?:** Yes.**History:** 2002**Comments:** This component factors the roof for Buildings #137, 138 & 140, which were reportedly last replaced in 2002. See Component #600 for more detailed comments and recommendations.**Useful Life:**

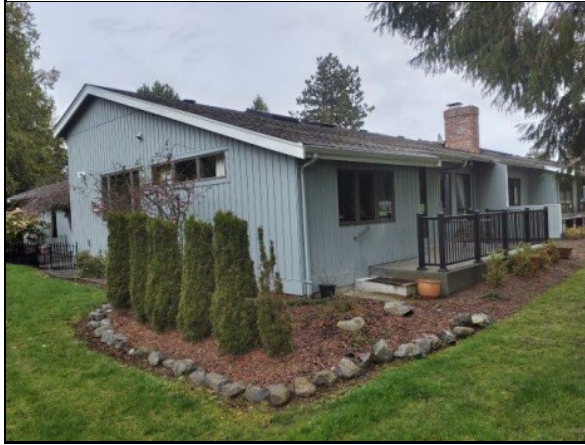
Comp #: 603 Comp Roof (142) - Replace**Quantity: ~ 9,200 SF****Location:** Rooftop of Units #142**Funded?:** Yes.**History:** 2003**Comments:** This component factors the roof for Building #142, which was reportedly last replaced in 2003. See Component #600 for more detailed comments and recommendations.**Useful Life:**

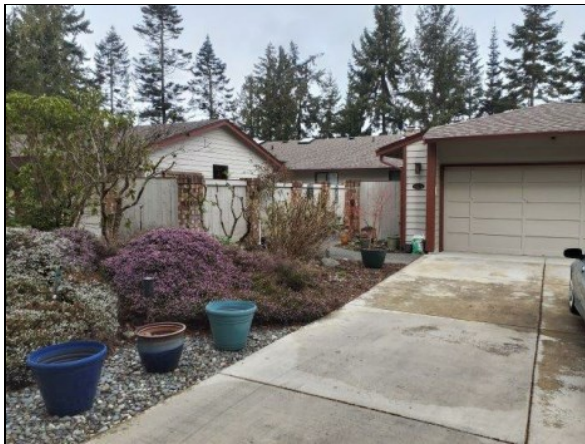
Comp #: 605 Comp Roof (148) - Replace**Quantity: ~ 9,400 SF****Location:** Rooftop of Units #148**Funded?:** Yes.**History:** 2005**Comments:** This component factors the roof for Building #148, which was reportedly last replaced in 2005. See Component #600 for more detailed comments and recommendations.**Useful Life:**

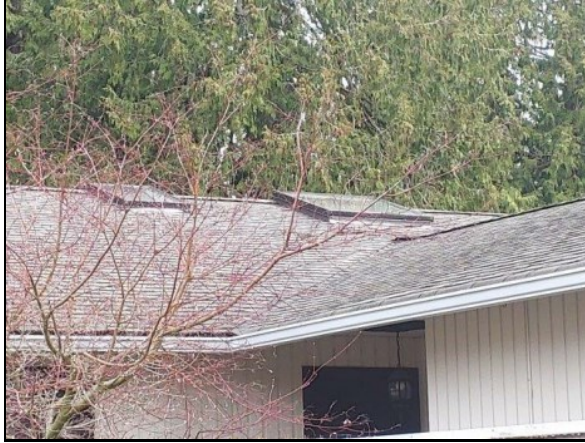
Comp #: 606 Comp Roof (143/145) - Replace**Quantity: ~ 5,000 SF****Location:** Rooftop of Units #143 & #145**Funded?:** Yes.**History:** 2006**Comments:** This component factors the roof for Buildings #143 & 145, which were reportedly last replaced in 2006. See Component #600 for more detailed comments and recommendations.**Useful Life:**

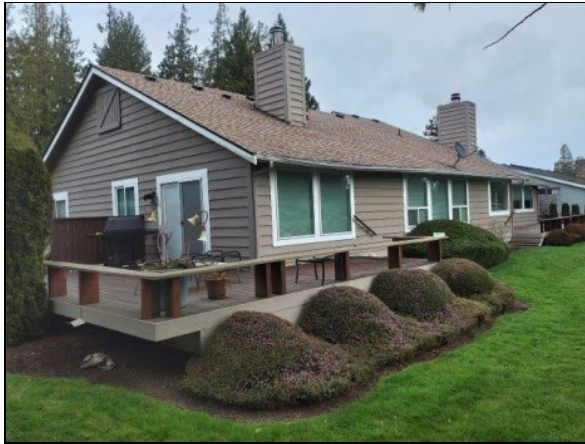
Comp #: 608 Comp Roof (117) - Replace**Quantity: ~ 7,000 SF****Location:** Rooftop of Units #117**Funded?:** Yes.**History:** 2018 ~\$27,500; 1998**Comments:** This component factors the roof for Building #117, which was reportedly last replaced in 2018. See Component #600 for more detailed comments and recommendations.**Useful Life:**

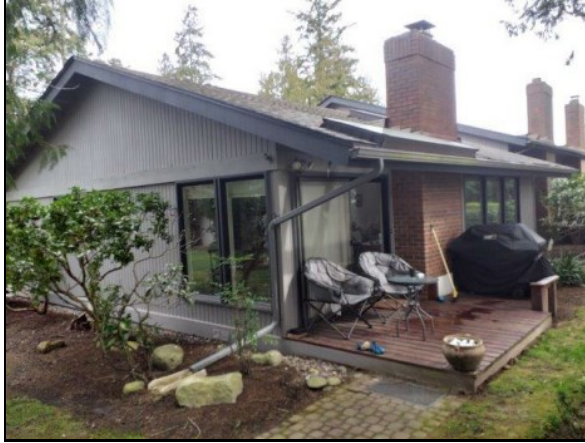
Comp #: 609 Comp Roof (119/121/134) - Replace**Quantity: ~ 21,800 SF****Location:** Rooftop of Units #119, #121 & #134**Funded?:** Yes.**History:** 2020 ~\$98,300; 1997/1998 #121 (A,B,C); 2018 #121 D; 2004**Comments:** This component factors the roof for Buildings #119, 121 & 134, which were reportedly last replaced in 2020. See Component #600 for more detailed comments and recommendations.**Useful Life:**

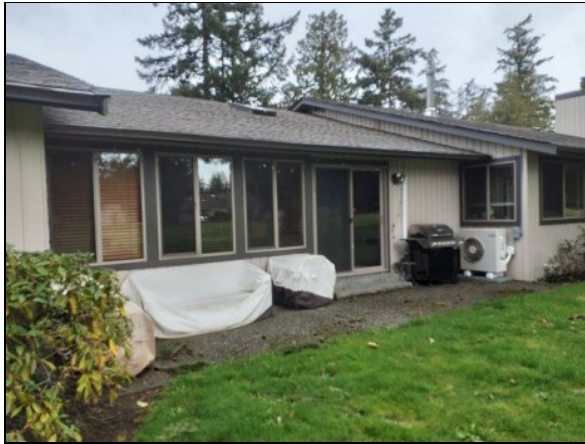
Comp #: 610 Comp Roof (108) - Replace**Quantity: ~ 9,700 SF****Location:** Rooftop of Units #108**Funded?:** Yes.**History:** 2022 ~\$83,032; 1997**Comments:** This component factors the roof for Building #108, which was reportedly last replaced in 2022. See Component #600 for more detailed comments and recommendations.**Useful Life:**

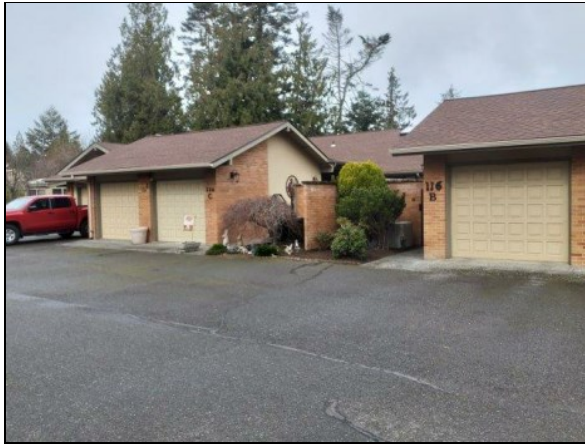
Comp #: 611 Comp Roof (116) - Replace**Quantity: ~ 10,300 SF****Location:** Rooftop of Units #116**Funded?:** Yes.**History:** 2023 ~\$88,303; 1998**Comments:** This component factors the roof for Building #116, which was reportedly last replaced in 2023. See Component #600 for more detailed comments and recommendations.**Useful Life:**

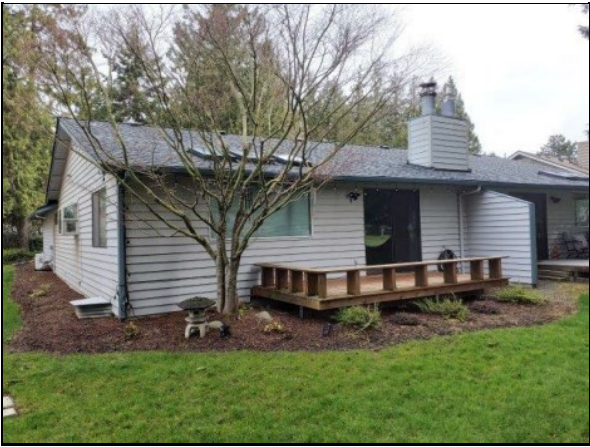
Comp #: 612 Comp Roof (147/149) - Replace

Comments: This component factors the roof for Buildings #147 & 149, which were reportedly last replaced in 2024. See Component #600 for more detailed comments and recommendations.

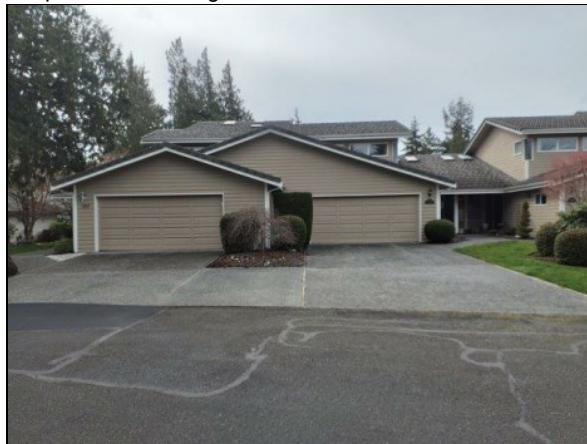
Comp #: 614 Tile Roofs - Replace**Quantity: ~ 21,500 SF****Location:** Rooftop of Units 151/153/155 & 157/159/161/163 (2 buildings)**Funded?:** Yes. Anticipated transition from tile roofs to composition shingle material**History:** Assumed original to Construction**Comments:** This component factors the tile roofs. The below allowances are based on the anticipation the roofing material is transitioned to composition shingle during the next replacement cycle. Costs related to tile materials are significantly higher.

Roof ventilation (the lack of which can greatly reduce the roof's useful life) was observed at eave and ridge. Eave venting consisted of circular holes in the blocking between rafters. Ridge venting appeared to be provided by continuous ridge vents, and roof jacks. Visible portions of roof flashing were observed at the rake, headwall, sidewalls. Diverter (kick-out) flashing was not observed. Gutters blocked the view of the eaves, so eave flashing was not confirmed. Debris and moss were not observed on the roof surface. A reserve study conducts only a limited visual review, and many of the critical waterproofing and ventilation items of the roof are not readily viewable. For a full evaluation, have a professional roof consultant/contractor perform a thorough up-close survey of your entire roof system, including an attic inspection (if any).

Concrete or clay tile should last in the 50-75 year range, but the underlayment and the wood battens beneath the roofing will likely need to be replaced sooner. As routine maintenance, many manufacturers recommend inspections at least twice annually (once in the fall before the rainy season and again in the spring), and after large storm events. Promptly replace any damaged/missing sections or any other repair needed to ensure the waterproof integrity of the roof. Keep the roof surface, gutters, and downspouts clear and free of moss or debris.

At the time of re-roofing, we recommend that you hire a professional consultant to evaluate the existing roof and specify the new roof materials/design, and provide installation oversight. We recommend that all associations hire qualified consultants whenever they are considering having work performed on any building envelope (waterproofing) components including the roof, walls, windows, decks, exterior painting, and caulking/sealant.

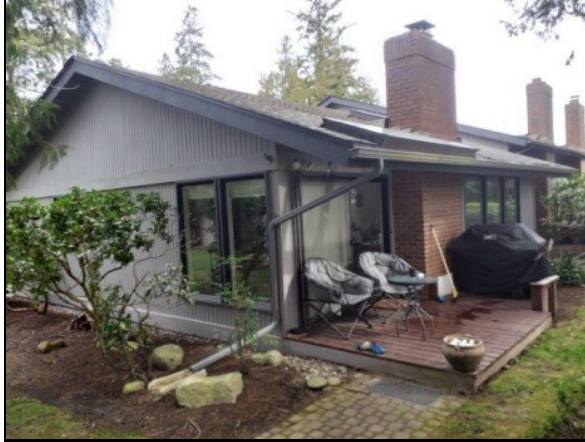
Comp #: 618 Gutters/Downspouts - Replace**Quantity: ~ 6,300 LF****Location:** Perimeter of buildings**Funded?:** No. Funding included within similar components; no separate funding necessary**History:** None known**Comments:** Based on our limited visual inspection, the metal gutters and downspouts appeared to be functional.

These installations have been historically included within prior roof replacement projects. Funding is included within similar roof replacement components; no separate funding is necessary.

As routine maintenance, inspect regularly, and keep gutters and downspouts free of debris.

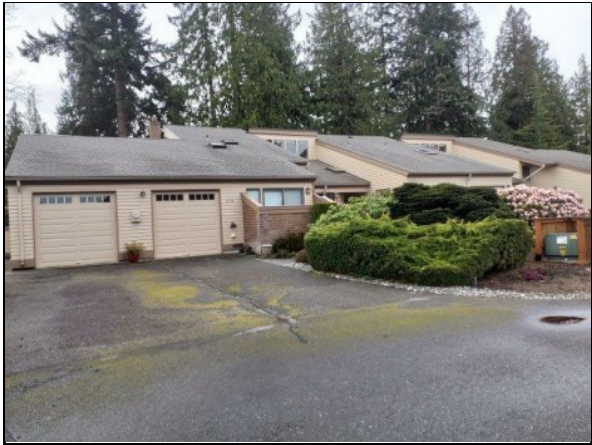
Comp #: 899 Plumbing - Systems Evaluation**Quantity: Supply & drain lines****Location:** Common plumbing**Funded?:** No. Operating expense in year of occurrence**History:** None known**Comments:** Plumbing systems are generally considered life limited by the engineering community. The costs for replacement can vary widely depending upon the specifications, site conditions, unit repairs after install, hazardous material handling, etc.

We highly recommend the association engage a qualified firm to conduct a baseline study, evaluating the plumbing systems (supply, waste, any fire system pipe), including forensic wall openings, and test sections of piping. Additional testing may be further recommended. Patterns of significant repair expenses, leaks, poor flow, and sediments in the lines, should accelerate the need to address proactively and seek a detailed analysis to identify hidden conditions, project a remaining useful life, and recommendations for any needed repairs, maintenance, etc. The costs can vary depending on the complexity of systems, the number of wall or ceiling openings, etc. Prior to such an evaluation, there is no predictable basis at this time for large-scale plumbing repair or replacement expenses. Results should be included in the subsequent reserve study update.
